Deterioration of Stone and Mineral Materials from the Roman Imperial “Villa of the Antonines” at Ancient Lanuvium

Gregory A. Pope, Deborah Chatr Aryamontri, Laying Wu,
and Timothy Renner

Abstract

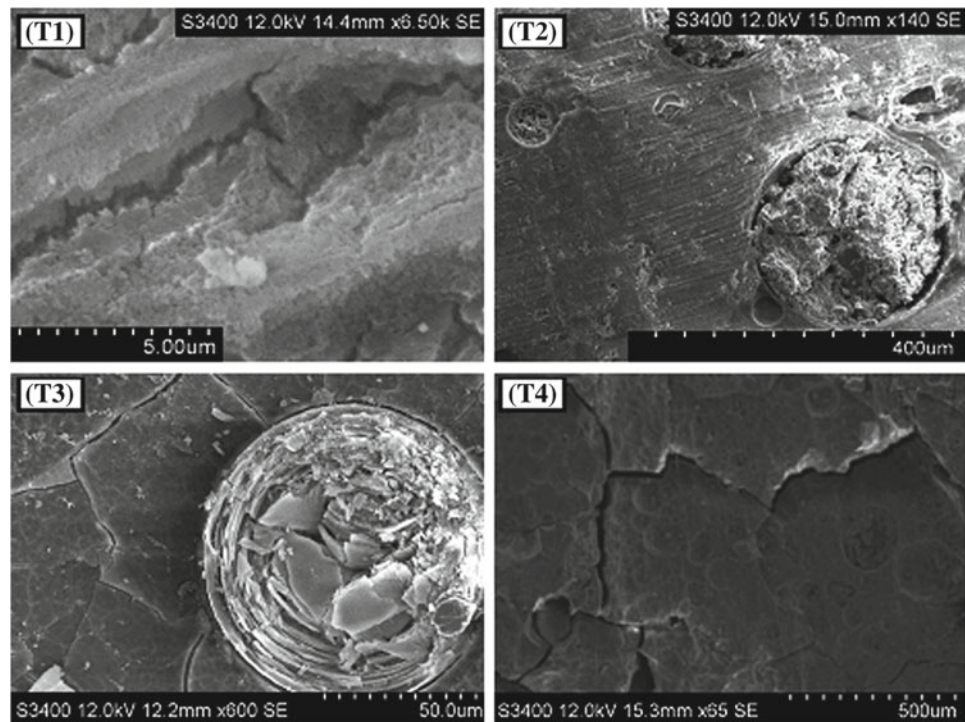
The most common features of the tesserae were shallow circular pits or craters, occasional on some surfaces such as T1 but ubiquitous and extensive on other surfaces, such as T3 and T4 (Fig. 87.4 lower right). The craters ranged in size from 20–80 µm in diameter and in depth <5 µm. We interpret these to be weathering features as they were limited to exposed surfaces and appeared to overlay manufacturing features, such as the striae. Cratering is probably related to chemical dissolution, described by Branda et al. (1999). Craters are not to be confused with often larger and deeper circular vesicles, interpreted as being bubbles in the glass, a product of manufacturing (Croveri et al. 2010). Bubbles do play a role in the surface deterioration, however. In the T1 sample, organic material filled several of these bubbles, which act as a protective location but also serve to retain biological weathering agents. (Fig. 87.4 upper right). In T3, an 80 µm bubble was completely filled with a flaked material, probably now clay (Fig. 87.4 lower left). This may have been an unmelted inclusion in the glass, perhaps of the sodic flux added to the raw material. It weathered into plates concentric to the circumference of the bubble.

Fig. 87.4 Surface weathering on tesserae: parallel cracking in grooves (**T1**); vesicle filled with organic material (**T2**); vesicle filled with clay, surrounded by mosaic fractures (**T3**); mosaic fracture patterns and shallow craters (**T4**)

surface stress, but from various causes. The smallest cracks define small ($<20\ \mu\text{m}$) polygonal flakes, best seen on T3 (Fig. 87.4 lower left) and T4, but not observed on T1 and T2 (concordant with the visibly better condition of T1 and T2). The cracks and polygonal flakes are shallow surface features. Likely, polygonal cracking is a result of glass corrosion in either a subsoil or subaerial environment, described by Römich (1999). Atmospheric or soil acids are capable of leaching the alkaline elements of the sodic components. While SEM-EDS identified the presence of alkaline elements on the glass surface (Fig. 87.5), specific element loss (compared to the interior of the specimen) awaits cross-sectional microanalysis.

Fine polygonal cracks were in some instances contained within angular surface blocks, defined by larger cracks up to $20\ \mu\text{m}$ wide. On the T4 specimen, these larger cracks cut through shallow craters or pits (Fig. 87.4 lower left and lower right). The crack-defined areas, $\sim 100\text{--}500\ \mu\text{m}$ in diameter, resemble macroscopic exfoliation seen on rock surfaces, and may be caused by temperature stress, salt crystal growth, hydration or dehydration of glass (which may originally contain up to 20 % water, Römich 1999), or

The third type of cracking, linear cracks (Fig. 87.4 upper left), appeared parallel to striations. We believe the striations, hundreds of μm long and $5\text{--}10\ \mu\text{m}$ wide, to be manufacturing artifacts, possibly from irregular cooling or mixing of raw material, from cutting the glass into tesserae, or from polishing the glass. Striations were not apparent on all surfaces, and linear cracking not apparent on all striations. The linear cracks, $\sim 0.5\ \mu\text{m}$ wide, formed in the “troughs” of the striations. Linear cracks may be the result of cooling and shrinking during manufacture, from post-manufacture exposure to temperature extremes, glass hydration/dehydration, clay expansion, or salt crystal growth below the plates (given the presence of Cl, Na, and K identified within the glass matrix, Fig. 87.5). The linear cracks are likewise large enough to allow entry for weathering agents, extending the deterioration feedback. Thin overgrowths or coatings were identified on flat surfaces, particularly on striated surfaces. These overgrowths are probably secondary deposits of silica.
