CARPARC DIEM GARAGE REPAIRS

MONTCLAIR STATE UNIVERSITY

PROJECT NO. 23C058

CARPARC DIEM GARAGE REPAIRS
 MONTCLAIR STATE UNIVERSITY (PROJECT NO. 23C058)
ROOF REPAIR PLAN
 TOWNSHIP OF LITTLE FALLS

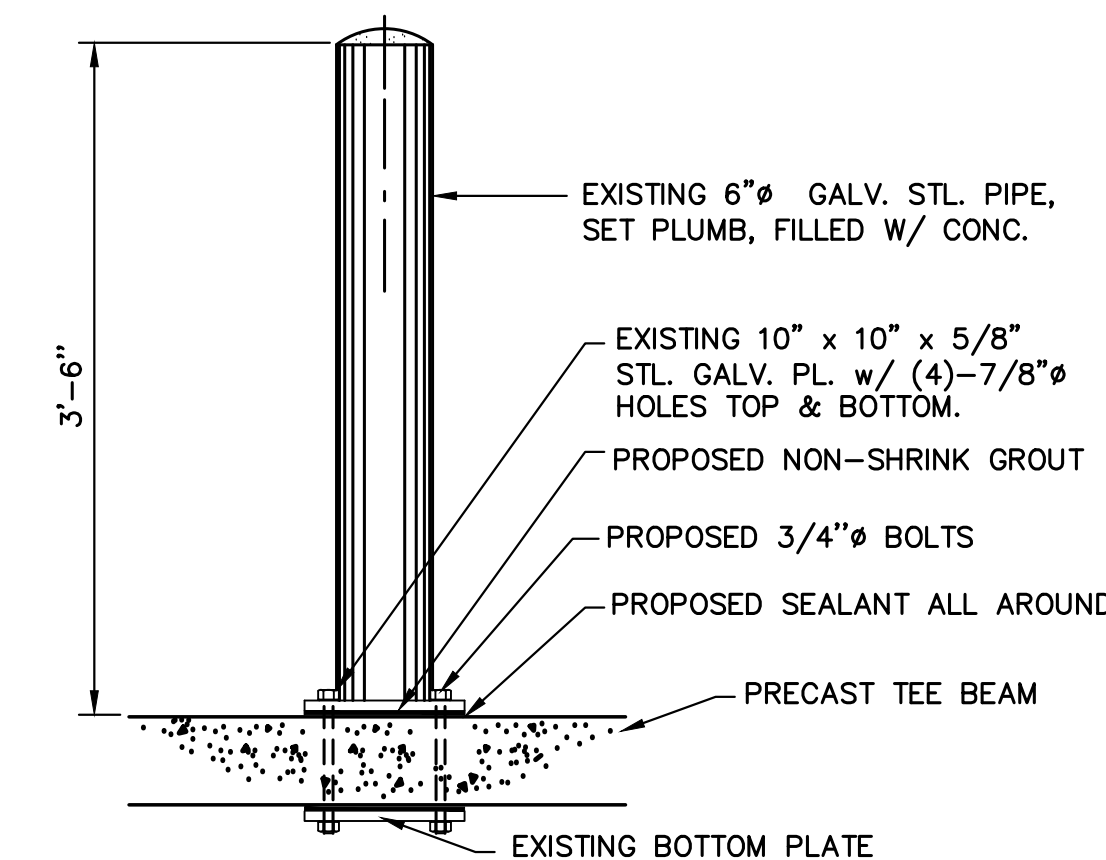
PIPE BOLLARD DETAIL 1
SCALE: N.T.S.

- 1) AT ALL BOLLARDS, PROVIDE 1" THICK MIN. LEVELING NON-SHRINK GROUT.
- 2) ALL RESET BOLLARDS SHALL FOLLOW "PIPE BOLLARD DETAIL 1", IF THIS CONDITION ARE FEASIBLE, "PIPE BOLLARD DETAIL 2" SHALL BE USED AS AN ALTERNATE AS NECESSARY.

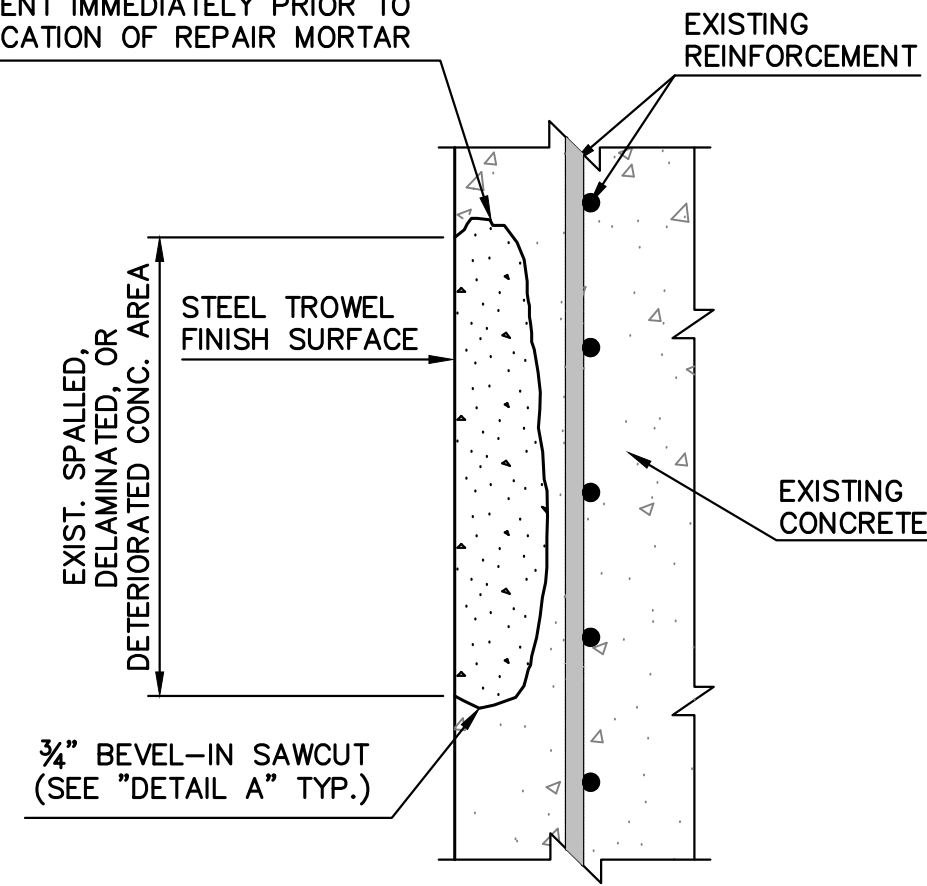
REPAIR OF CONCRETE, TYPE 1
SCALE: N.T.S.

REMOVE DETERIORATED MATERIAL TO SOUND CONC. LEAVING NO OFFSET OR ABRUPT CHANGES IN CONTOUR. FINAL SOUND SURFACE SHALL BE SANDBLASTED, CLEANED, AIR-BLOWN AND COATED WITH BONDING AGENT IMMEDIATELY PRIOR TO APPLICATION OF REPAIR MORTAR

CONCRETE REPAIR TYPE 1

THIS REPAIR SHALL BE USED AT ALL AREAS OF DETERIORATION ON THE VERTICAL AND OVERHEAD SURFACES OF BEAMS, SLABS, COLUMNS, AND MISCELLANEOUS CONCRETE WHERE DETERIORATION WITH NO MORE THAN 25% OF REBAR SURFACE IS EXPOSED AND A DEPTH OF 2 INCHES OR LESS.

1. CHIP AND REMOVE UNSOUND AND DELAMINATED CONCRETE TO A MINIMUM DEPTH OF 3/4" OR TO THE ADDITIONAL DEPTH NECESSARY TO REACH SOUND CONCRETE. LIMIT THE SIZE OF CHIPPING HAMMERS TO 15 LBS TO REDUCE MICRO FRACTURES. DO NOT USE A METHOD OF SURFACE PREPARATION THAT WILL FRACTURE THE CONCRETE. VERIFY THE ABSENCE OF MICROCRACKING OR BRUISING IN ACCORDANCE WITH INTERNATIONAL CONCRETE REPAIR INSTITUTE (ICRI) GUIDELINE NO. 03732.
2. ALL EXPOSED STEEL REINFORCING SHALL BE EPOXY COATED.

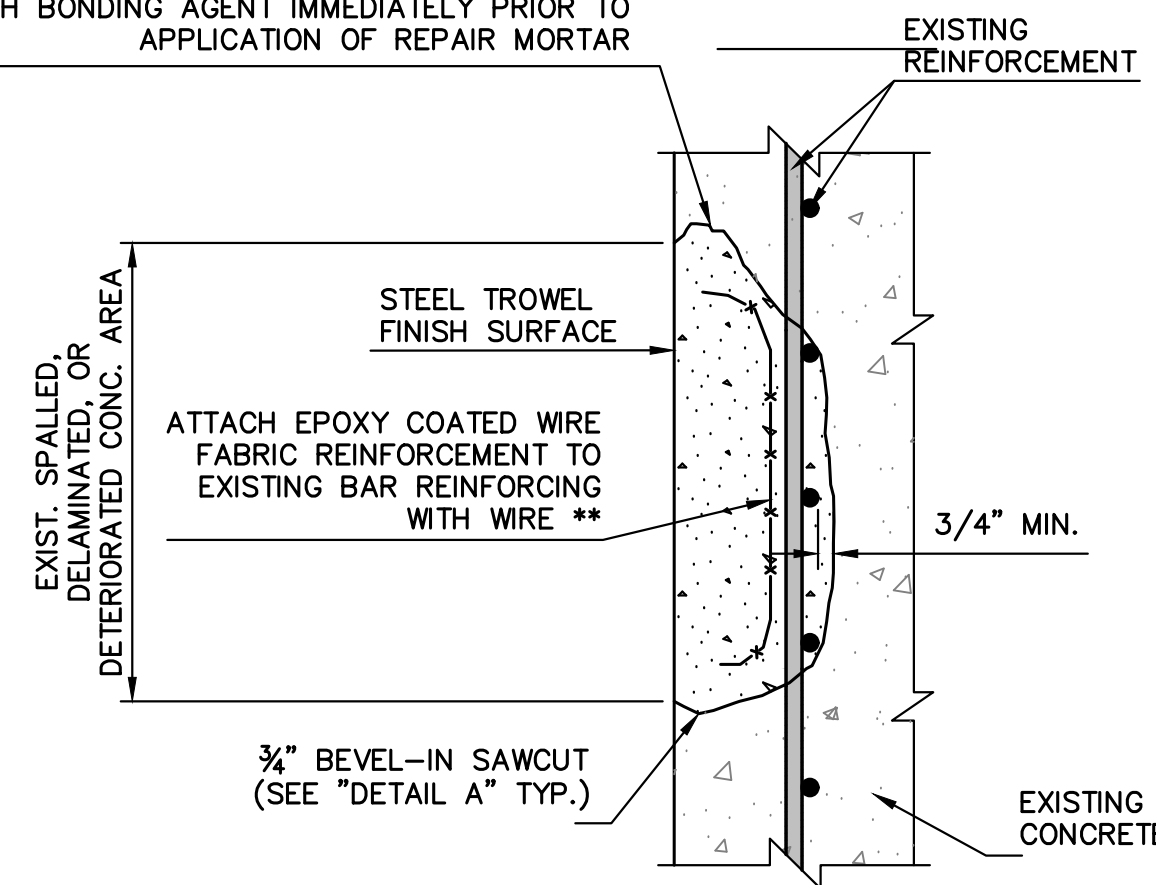
REMOVE DETERIORATED MATERIAL TO SOUND CONC. LEAVING NO OFFSET OR ABRUPT CHANGES IN CONTOUR. FINAL SOUND SURFACE SHALL BE SANDBLASTED, CLEANED, AIR-BLOWN AND COATED WITH BONDING AGENT IMMEDIATELY PRIOR TO APPLICATION OF REPAIR MORTAR

REPAIR OF CONCRETE, TYPE 2
N.T.S.
** WIRE FABRIC SHALL BE 6" X 6" W2.9 XW2.9

CONCRETE REPAIR TYPE 2

THIS REPAIR SHALL BE USED AT ALL AREAS OF DETERIORATION ON THE VERTICAL AND OVERHEAD SURFACES OF BEAMS, SLABS, COLUMNS, AND MISCELLANEOUS CONCRETE WHERE DETERIORATION WITH MORE THAN 25% OF REBAR SURFACE IS EXPOSED OR A DEPTH OF GREATER THAN 2 INCHES.

1. CHIP AND REMOVE UNSOUND AND DELAMINATED CONCRETE TO A DEPTH MINIMUM DEPTH 3/4" OR TO THE ADDITIONAL DEPTH NECESSARY TO REACH SOUND CONCRETE. WHERE STEEL REINFORCEMENT HAS MORE THAN 25% OF ITS SURFACE ARE EXPOSED THE CONCRETE SHALL BE REMOVED TO 3/4" BELOW THE REINFORCING. LIMIT THE SIZE OF CHIPPING HAMMERS TO 15 LBS TO REDUCE MICRO FRACTURES. DO NOT USE A METHOD OF SURFACE PREPARATION THAT WILL FRACTURE THE CONCRETE. VERIFY THE ABSENCE OF MICROCRACKING OR BRUISING IN ACCORDANCE WITH ICRI GUIDELINE NO. 03732.

2. ALL EXPOSED STEEL REINFORCING SHALL BE EPOXY COATED. ALL DETERIORATED REINFORCEMENT SHALL BE TREATED AS FOLLOWS:
 - A. SECTION LOSS LESS THAN 25%: THE REBAR SHALL BE CLEANED AND EPOXY COATED.

- B. SECTION LOSS BETWEEN 25% AND 50%: THE REBAR SHALL BE CLEANED AND EPOXY COATED AND LAPPED WITH A SUPPLEMENTARY REBAR OF EQUAL DIAMETER.
 - C. SECTION LOSS MORE THAN 50%: THE REBAR SHALL BE CUT AND REPLACED WITH NEW REINFORCEMENT (NO WELDING ALLOWED ON POST-TENSIONED TENDONS) AS DIRECTED BY THE ENGINEER.

3. THE NEW REINFORCEMENT COULD BE WELDED, LAP SPLICED OR ANCHORED IN THE CONCRETE DEPENDING ON EACH INDIVIDUAL CASE AS DIRECTED BY THE ENGINEER.
4. MAXIMUM REPAIR MORTAR APPLICATION THICKNESS SHALL BE AS RECOMMENDED BY THE MANUFACTURER BUT NOT TO EXCEED 3".

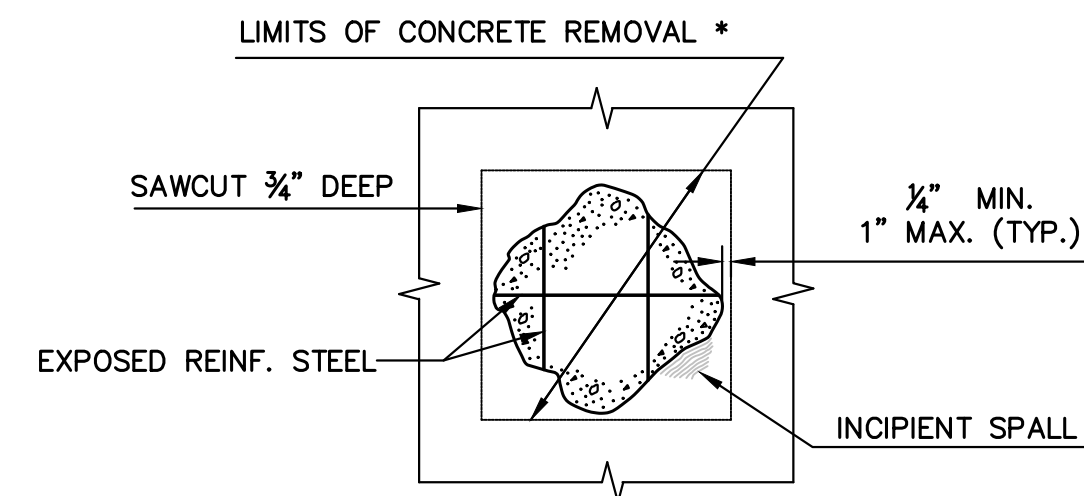
LIMITS OF REPAIR AREA (PLAN VIEW)
"DETAIL A"
N.T.S.

* EXTEND LIMITS OF CONCRETE REMOVAL WHEN ADDITIONAL REINFORCEMENT IS REQUIRED PER REPAIR TYPE 2.

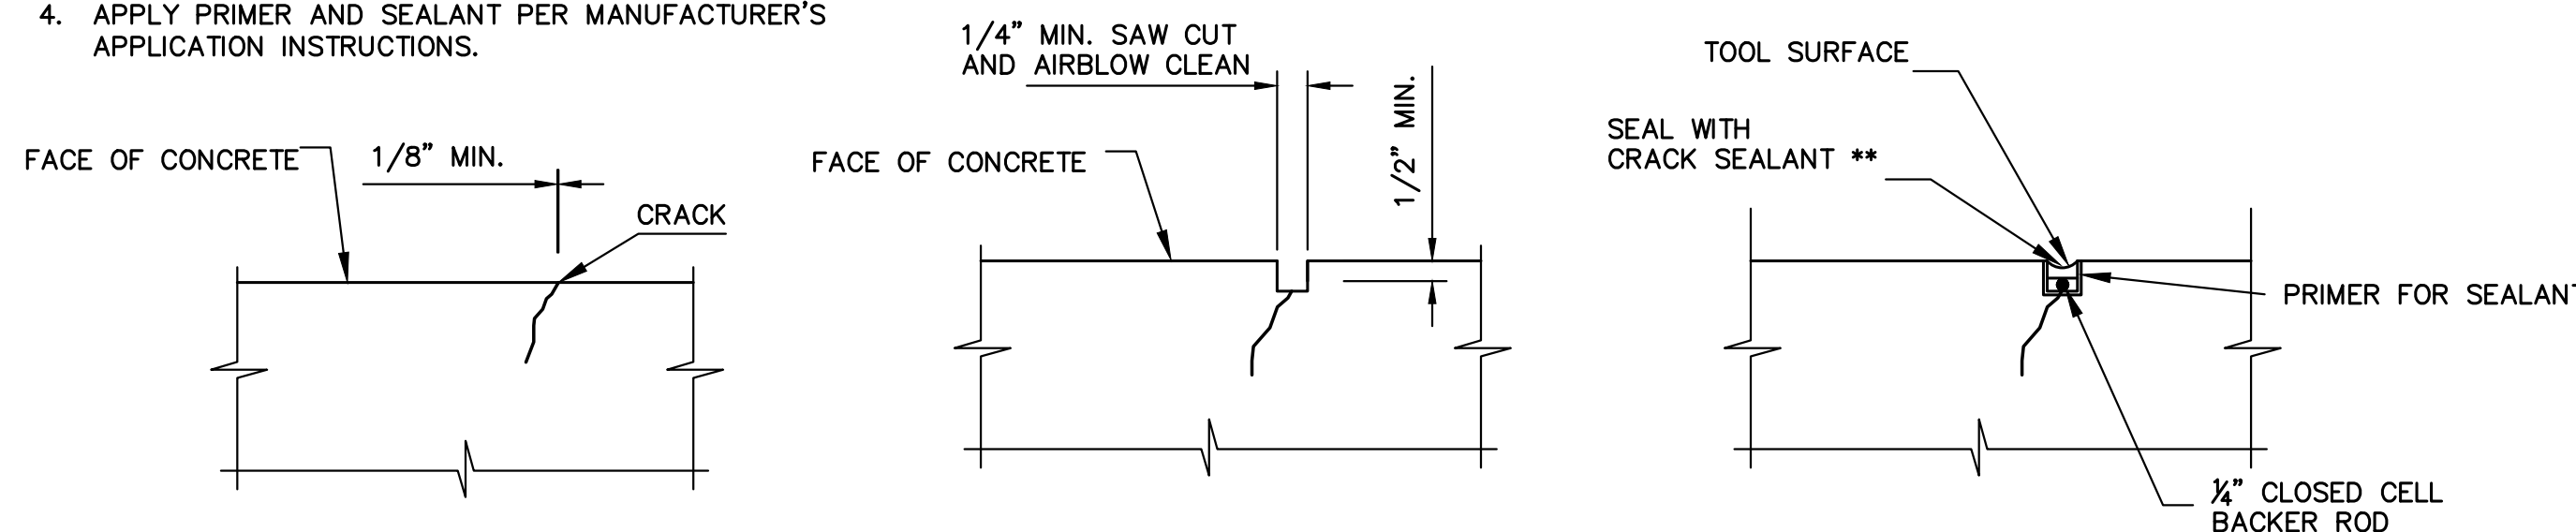
TYPICAL CRACK REPAIR

EXISTING CRACK
SCALE: N.T.S.

PREPARATION
SCALE: N.T.S.

CRACK SEALING
SCALE: N.T.S.

** CRACK SEALANT SHALL BE MASTERSEAL SL2 BY BASF BUILDING SYSTEMS OR APPROVED EQUAL.

CRACK REPAIR

1. SAW CUT ALONG CRACK, 1/2" WIDE x 1/2" DEEP.
2. PREPARE SURFACE FOR SEALANT BY GRINDING OR WIRE BRUSHING TO EXPOSE A SOUND SURFACE FREE OF CONTAMINATION AND LAITANCE.
3. PLACE BACKER ROD AT BOTTOM OF PREPARED ROUT.
4. APPLY PRIMER AND SEALANT PER MANUFACTURER'S APPLICATION INSTRUCTIONS.
